Spindle Assembly

Clobberbots

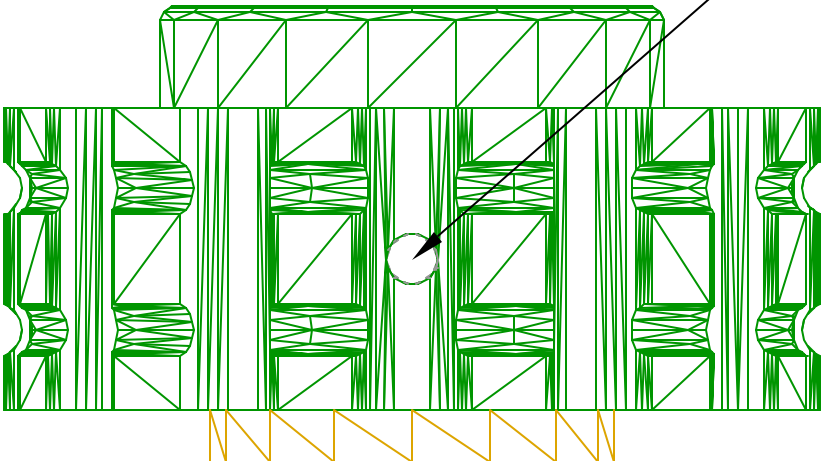
1/8" shear  
pin  
prevents  
sprocket  
from  
lateral  
movement  
on the  
spindle.

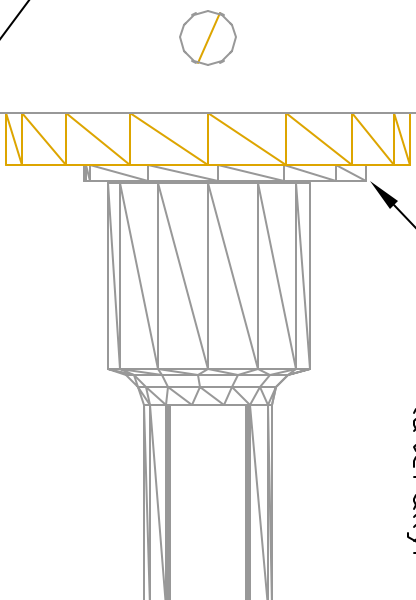
Retaining ring  
prevents spindle  
assembly from sliding  
laterally.

Bronze oil impregnated  
thrust bushing with  
1/2" ID,  
Bronze oil impregnated  
flange bushing with  
1/2" ID, 3/4" OD.
